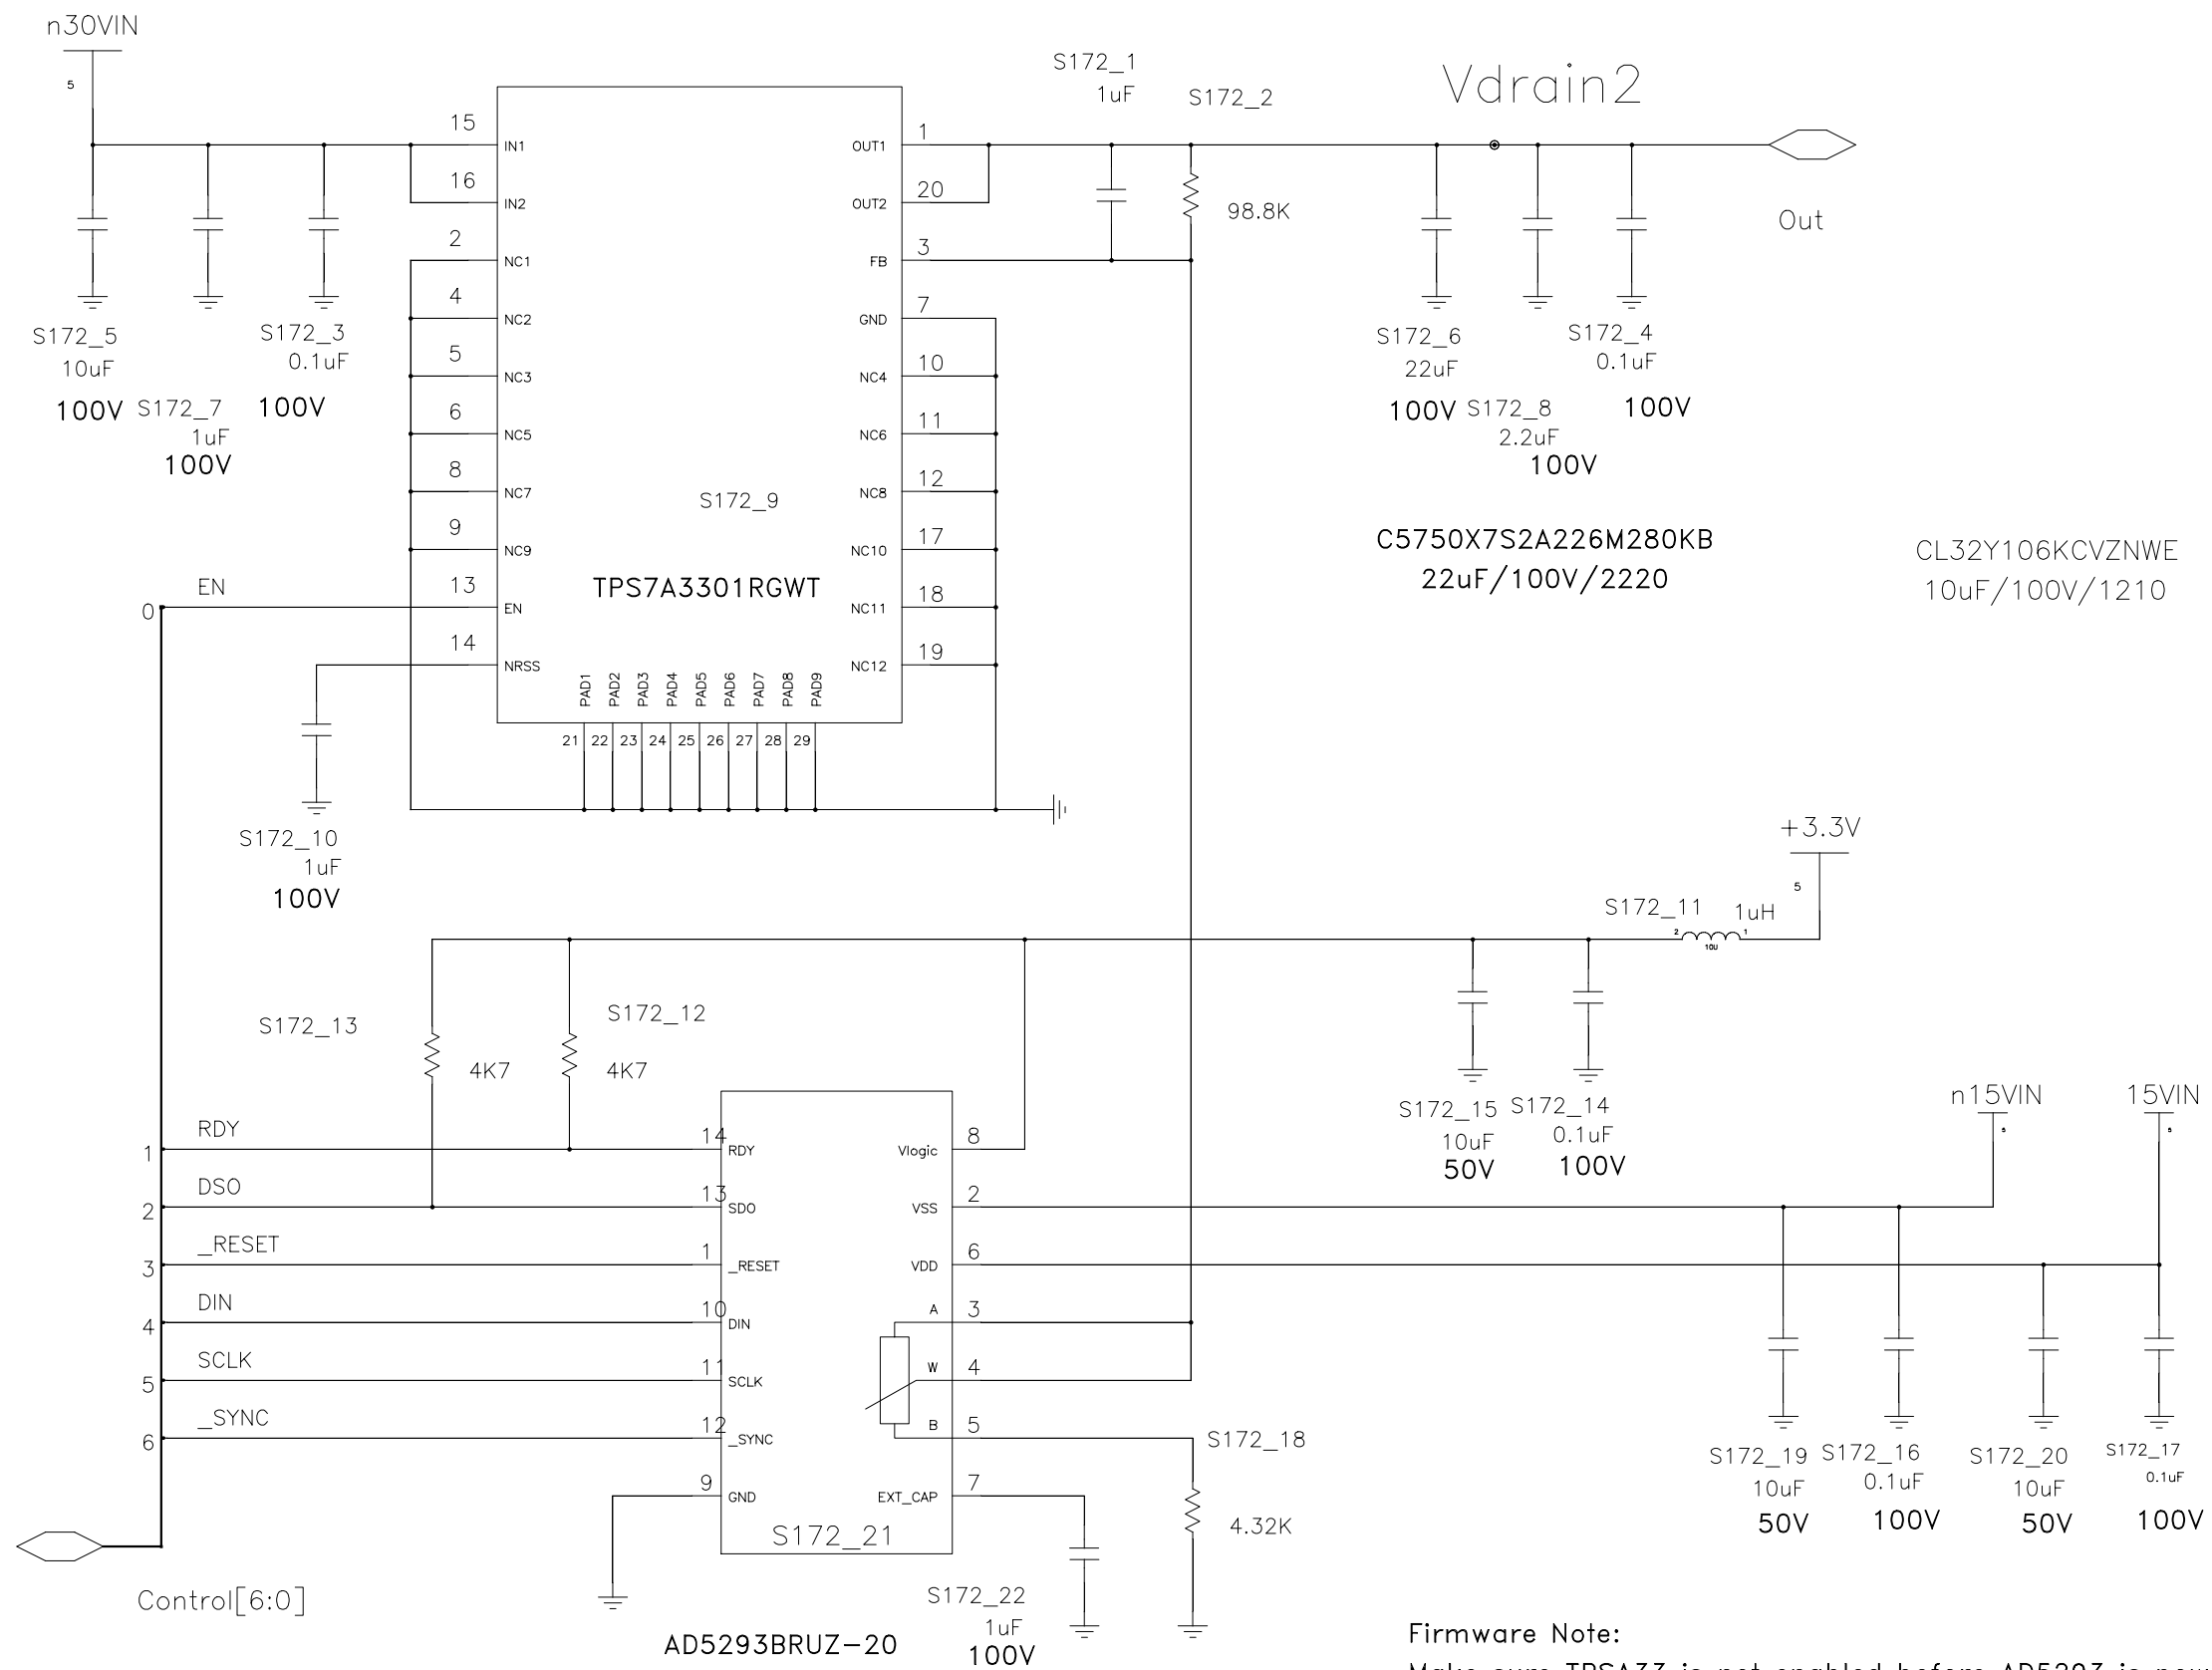
Firmware Note:  
Make sure TPSA33 is not enabled before AD5293 is powered up.
